**Docket No. 217 – Development and Management Plan Inspection**

Northeast Utilities Service Company Certificate of Environmental Compatibility and Public Need for the construction of a 345-kV electric transmission line and reconstruction of an existing 115-kV electric transmission line between Connecticut Light and Power Company's Plumtree Substation in Bethel, through the towns of Redding, Weston, and Wilton, and to the Norwalk Substation in Norwalk, Connecticut.

**Date:** September 29, 2005

**Location:** Norwalk Substation Expansion

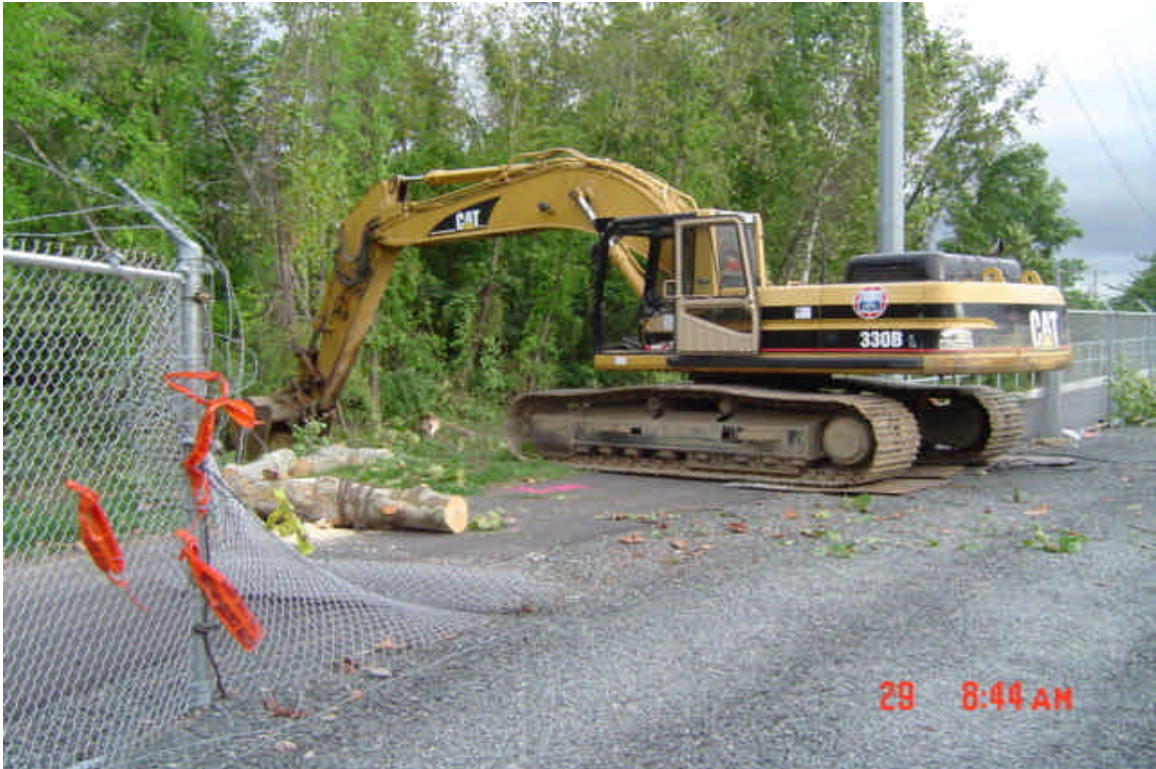
Norwalk Substation: The perimeter fence has been removed in this location so that equipment can access the area to be cleared and crossed for the structure installation. (9/29/05)

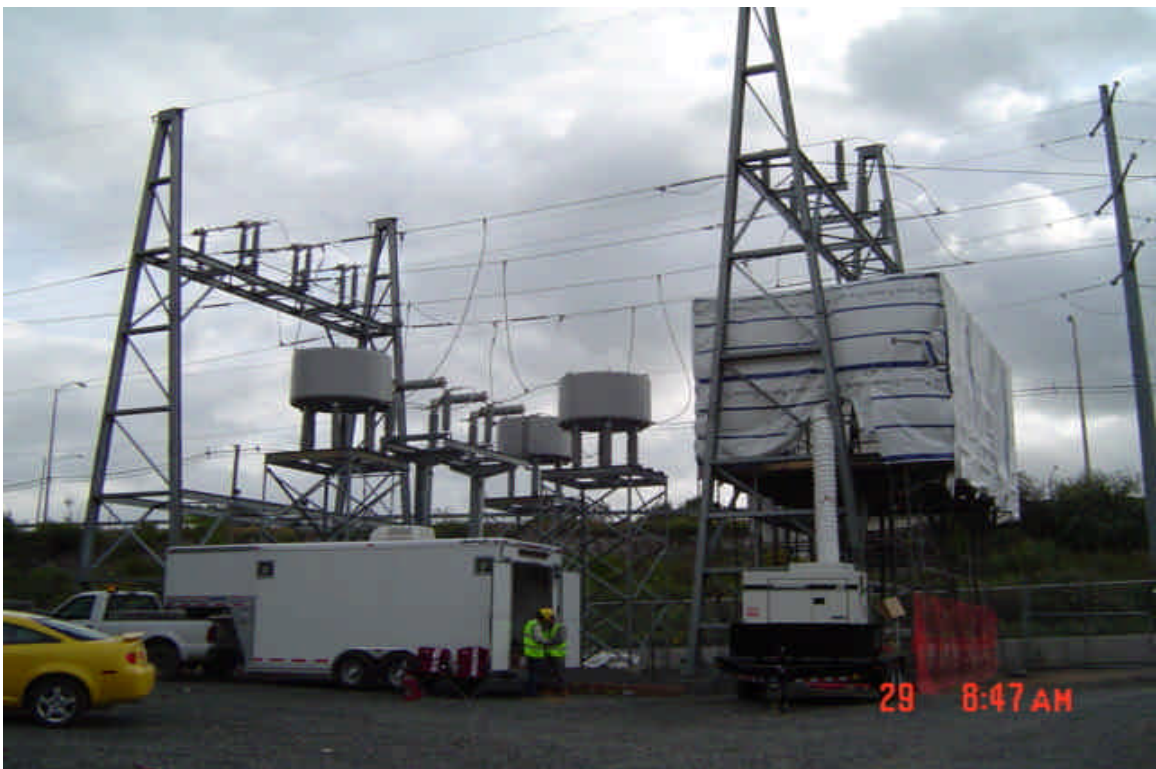
View of the northern portion of the substation. (9/29/05)

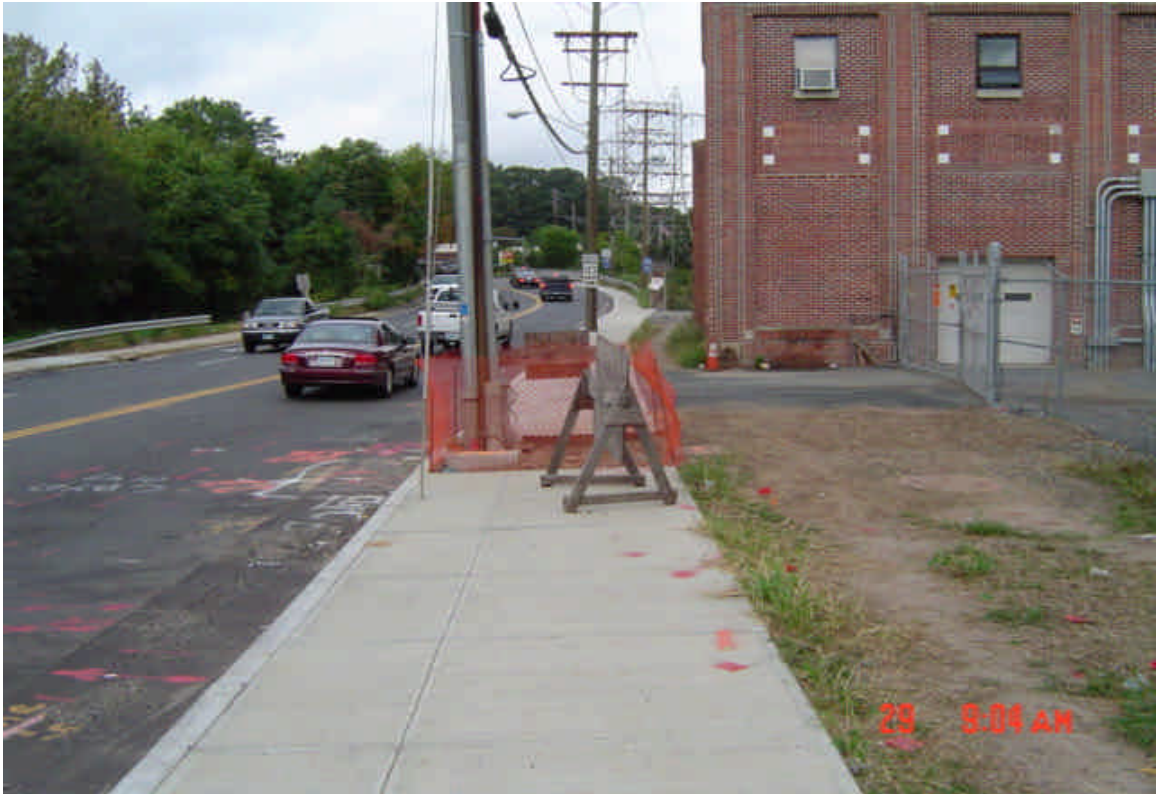
View of the sidewalk along New Canaan Ave. where some utility work had recently taken place.  
(9/29/05)

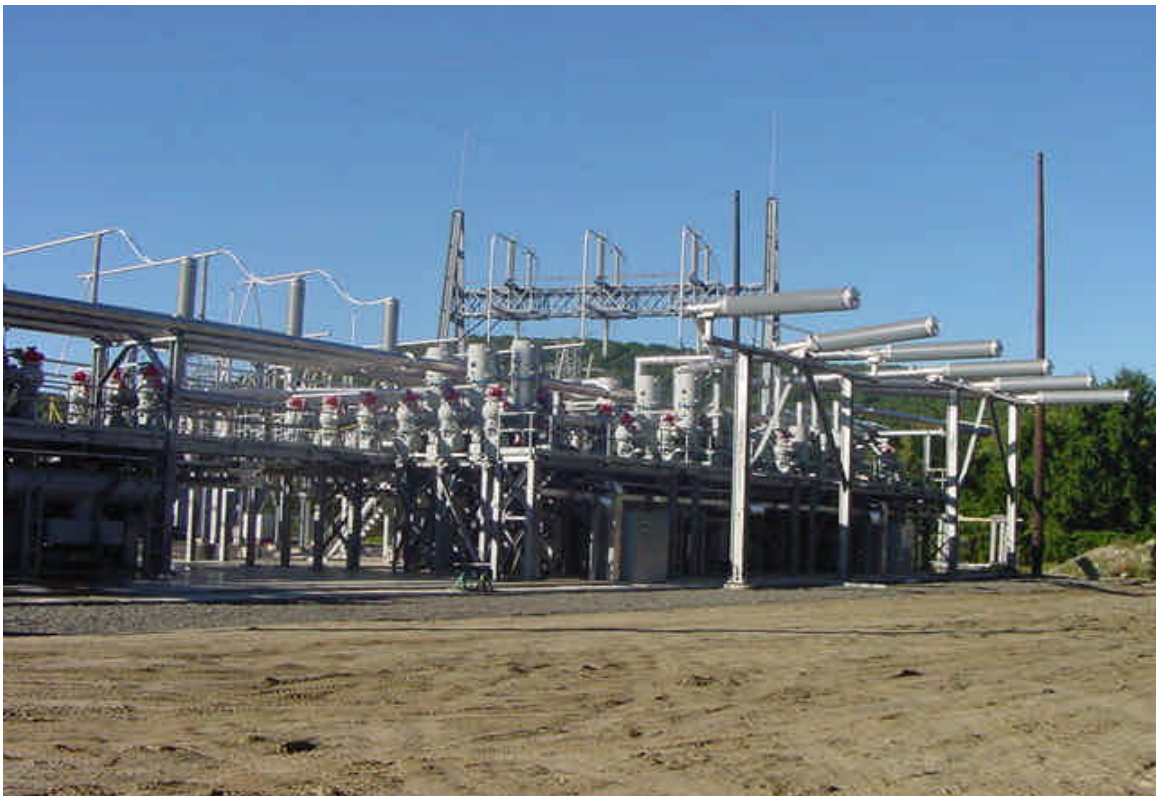
Plumtree Substation: Work continues on structures connecting to the equipment on the concrete pad. (9/29/05)
